## 2. Evaluation of Upward Drilling Corrosion in Glass Furnace

Ryunosuke Kuroda\*

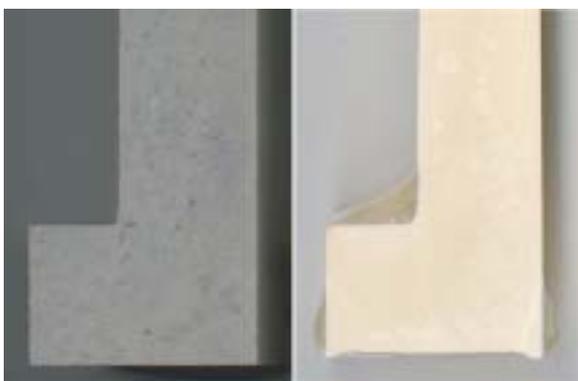
The test piece is prepared from near the skin of fused ZrO<sub>2</sub> ingot and is characterized by the more homogeneous microstructure in comparison with that of the interior. The bottom plane after the test was very smooth and any noticeable drilling hole was not observed. The lowest point of vertical plane, i.e., the edge of horizontal plane, was not

**Fig. 2A Cross sections of FZ-A before (left) and after (right) the corrosion test.**

so corroded. It is considered that the bubbles were not captured and drifted under the bottom plane because they could not escape due to the downward flow of high ZrO<sub>2</sub> containing glass which were formed at the vertical boundary between FZ-A and glass (Figs. 2A and 2B).

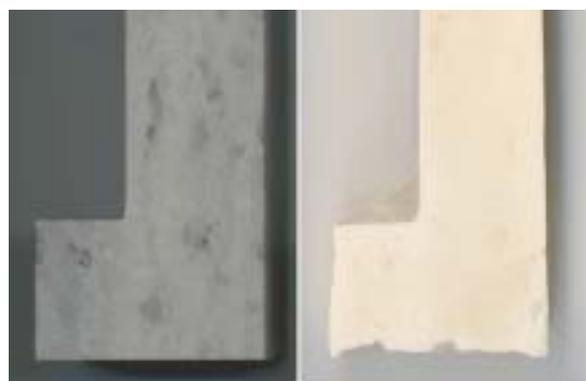
Both horizontal and vertical planes after the test were very rough and several drilling holes were observed at the bottom (Fig. 3A). WT can easily capture bubbles at the bottom plane because the softened matrix glass is rich there and would be the origin of upward drilling corrosion (Fig. 3C).

**Fig. 3A Cross sections of FZ-B before (left) and after (right) the corrosion test.**

Existence of WT also lowers the corrosion resistance generally. Corrosion along the vertical plane is often started from WT, although it is not deeper than upward drilling corrosion found at the bottom plane. The edge of horizontal plane was not so corroded as well as that of FZ-A (Figs. 3A and 3B).

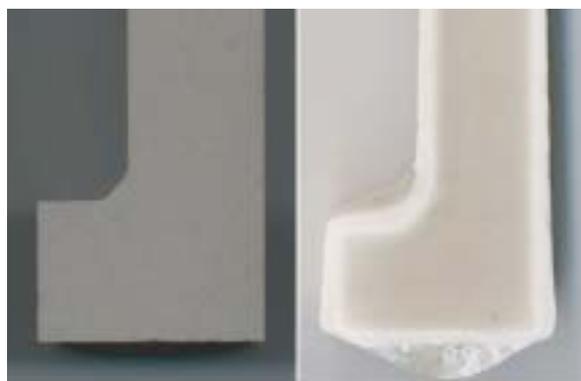
The test piece showed slight expansion after the corrosion test (Z-O in Fig. 4B). The region near the skin changed in color from gray to white, and was constituted from pie-sheet-like aggregates of baddeleyite and SiO<sub>2</sub>-rich glass (Fig. 4A). Those are considered to be formed as a result of reaction between zircon refractory and molten glass. The thickness of this reaction layer is about 2mm at the vertical plane and 1mm at the bottom plane.

Fig. 4A Cross sections of Zircon before (left) and after (right) the corrosion test.

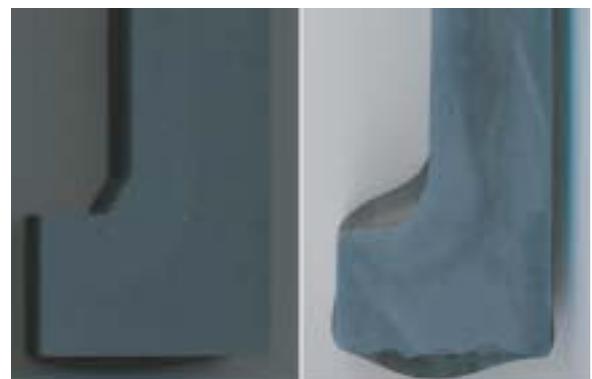
Typical upward drilling phenomenon was observed in this refractory.

The corroded surface was smooth although many drilling holes were formed. The size of these holes is wide compared with that of FZ-B although the depth of them is almost the same (Figs. 5A and 5B).

Fig. 5A Cross sections of Tin-oxide before (left) and after (right) the corrosion test.
